DETECTION OF INTERGRANULAR CORROSION IN COLD PLATE FACE SHEETS

William P. Winfree, Stephen W. Smith, Robert S. Piascik, Patricia A. Howell
NASA Langley Research Center,
Hampton, VA

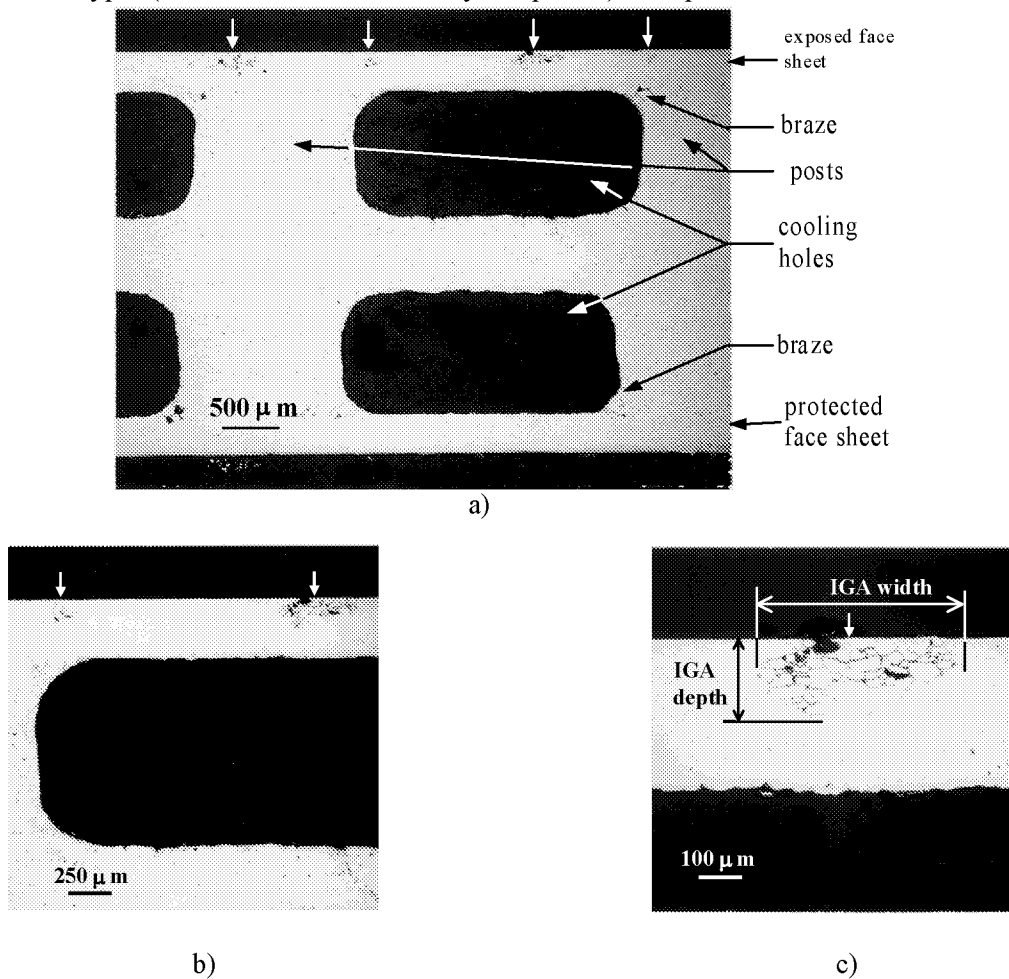
Initial destructive examinations were performed on corroded cold plate samples to evaluate the morphology of the IGA and to compare these results with the IGA observed in cold plates removed from the orbiter. Figure 2 contains a series of optical micrographs for a corroded sample that was exposed to the electrolyte solution for 24 hours, sectioned and polished. Several discreet corrosion events, identified by arrows in Figures 2a and b, are identified along each section. Here, the 1-inch by 1-inch cold plate

sample was coupled to a 1-1/2-inch by 1-1/2-inch steel cathode and immersed in the electrolyte. The resultant IGA was very similar to that observed for in-service cold plates. For each event, a maximum penetration depth and width were recorded (see Figure 2c). Such measurements were performed for several specimens exposed to the electrolyte solution for various times. Figure 3 shows results of depth versus width of IGA for three specimens exposed to the electrolyte for 8 hours (Figure 2a) and three specimens exposed for 24 hours (Figure 2b). Each specimen was polished six times, to examine six different cross-sections. Microscopic measurements of width, depth and position for all IGA events were performed on each metallographic section, to provide an accurate assessment of the IGA events. As can be seen in Figure 3, the average depth and width for the observed IGA was greater when the cold plate samples were exposed to the solution for 24 hours (see Figure 3b) than when they were exposed for 8 hours (see Figure 3a). To ensure that the NDE standards contained a wide distribution of IGA events, two NDE standard types (24 hour and 8 hour electrolyte exposure) were produced.

Figures 2 a-c. Optical micrographs for three different magnification of IGA produced in a cold plate specimen in the laboratory. The 1-inch by 1-inch specimen was coupled to a 1-1/2-inch by 1-1/2-inch steel cathode and exposed to the electrolyte solution for 24 hours.

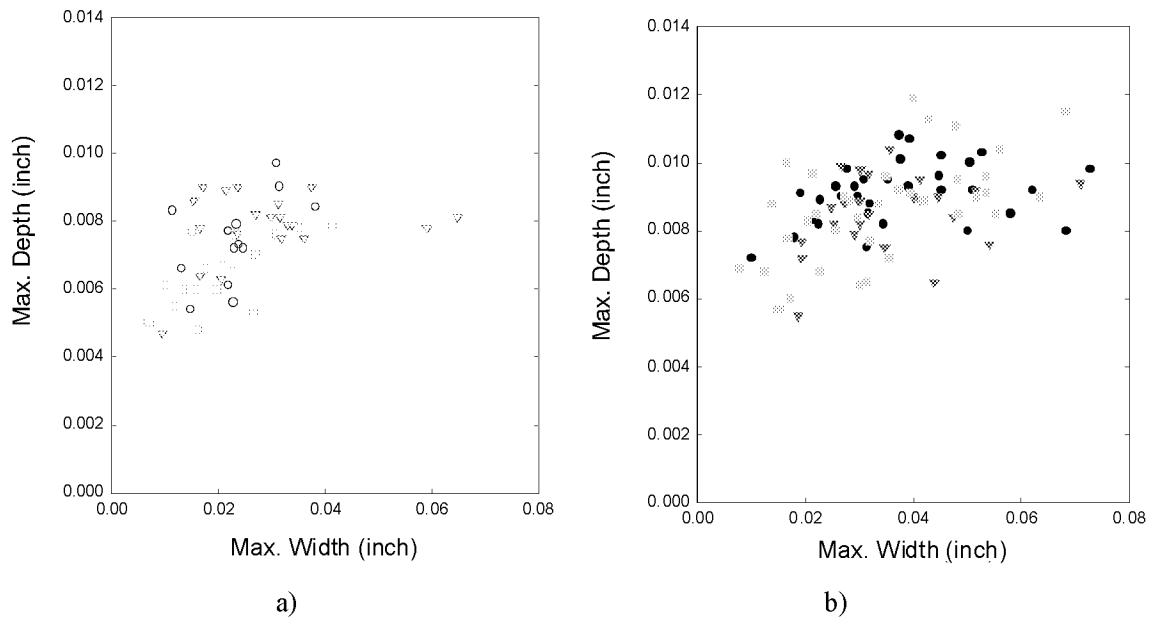
Figure 3. Plots showing depth versus width of IGA events measured using optical microscopy for cold plates specimens exposed to the electrolyte for a) 8 hours and b) 24 hours.

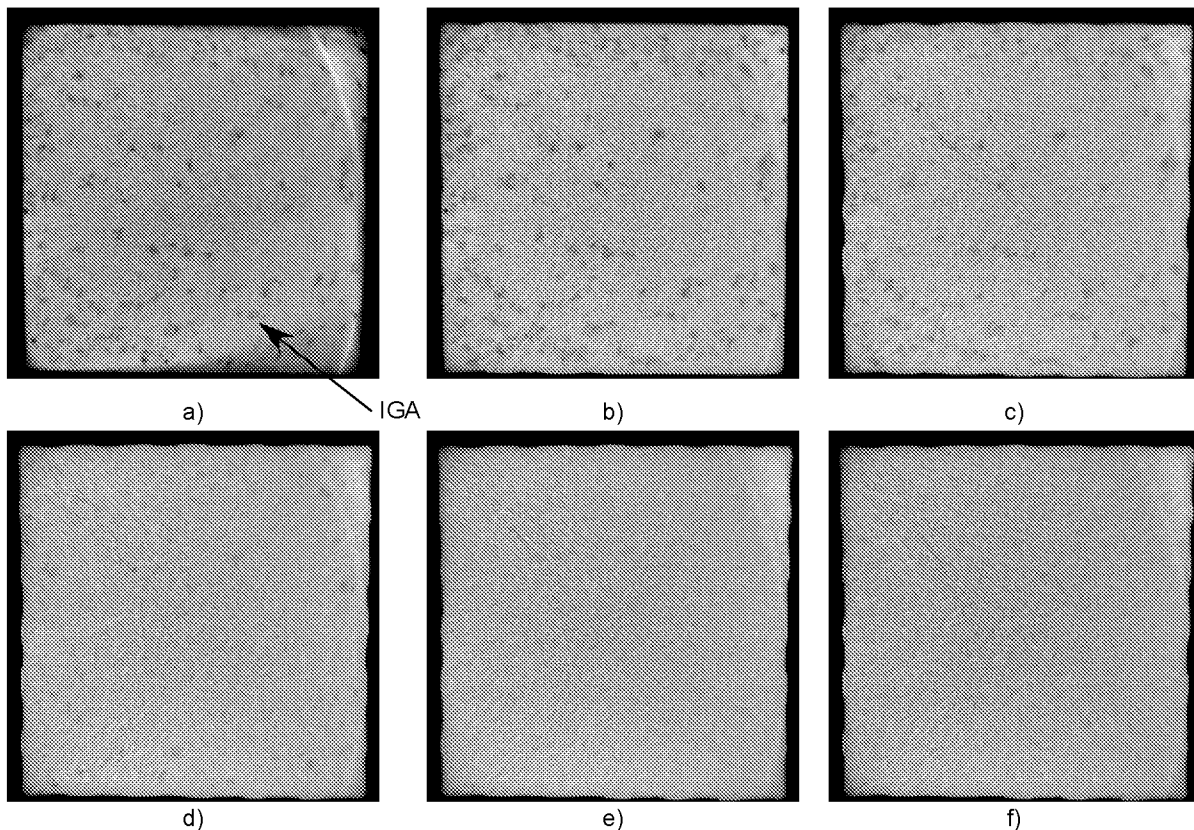
Figure 4. CT radiography images for a cold plate sample exposed to an electrolyte solution for 24 hours. The sensor head was located at a height that results in a mean sampling depth of 0.0135-inch. Average sampling depths are a) 0.0035-inch, b) 0.0055-inch, c) 0.0075-inch, d) 0.0095-inch, e) 0.0115-inch and f) 0.0135-inch

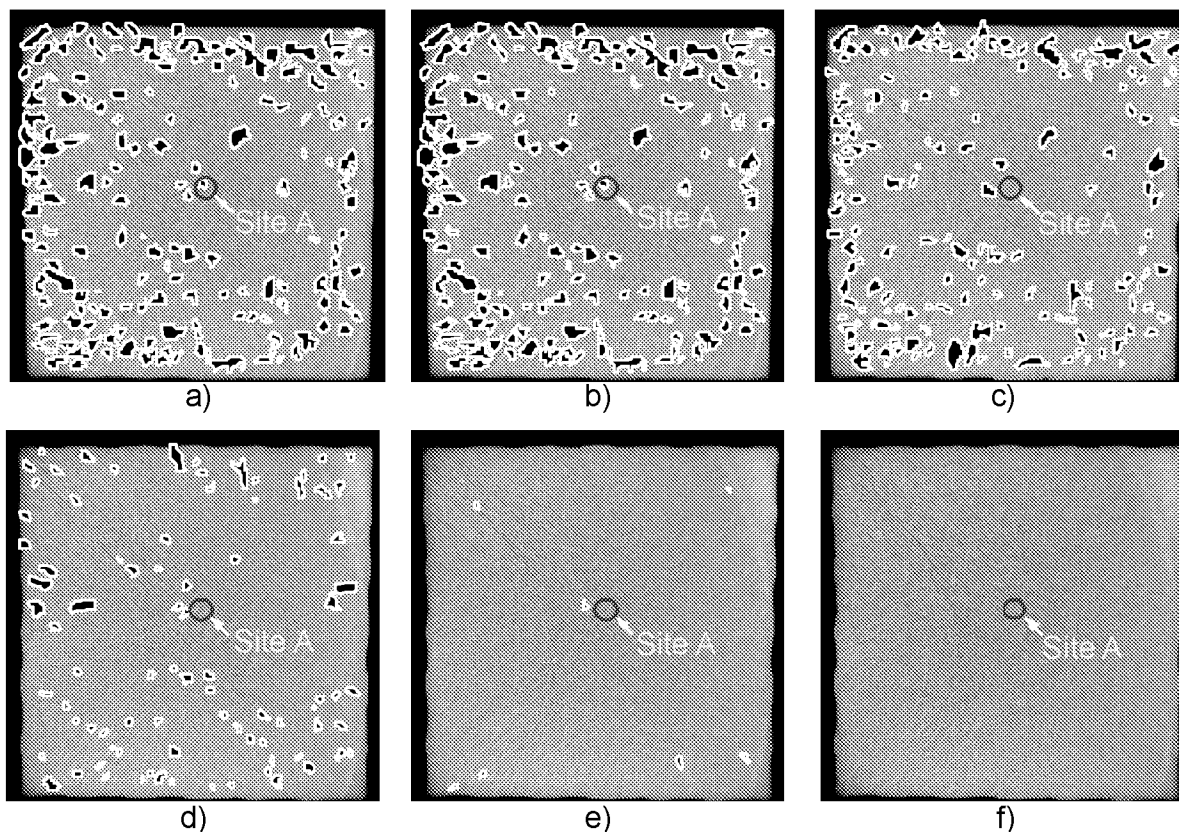
To validate the CT radiography results, metallography was performed to confirm IGA corrosion depth measurements. For each image in Figure 4, the suspected IGA events were identified in the images. The events identified in each image are shown in Figure 5. Because discrete depth images were produced, a mean maximum depth was determined for each IGA corrosion event. For example, a corrosion event is identified in region A in Figure 5a. Here, the event was observed for the 0.0035 and 0.0055-inch images (Figure 5 a and b) and was not observed at a depth of 0.0075-inch and greater (Figures 5 c-f). For this example, a mean maximum IGA depth of 0.0065-inch was determined for this event. Similarly, an IGA event would be determined to have a mean maximum depth of 0.0045-inch if it was identified at a depth of 0.0035-inch and not observed at the 0.0055-inch depth. If an event were identified in only one CT image, the event would be discarded from further consideration.

Figure 5. CT radiography images for a cold plate sample exposed to an electrolyte solution for 24 hours with IGA events identified. Average sampling depths are a) 0.0035-inch, b) 0.0055-inch, c) 0.0075-inch, d) 0.0095-inch, e) 0.0115-inch and f) 0.0135-inch. f) has no identified events.

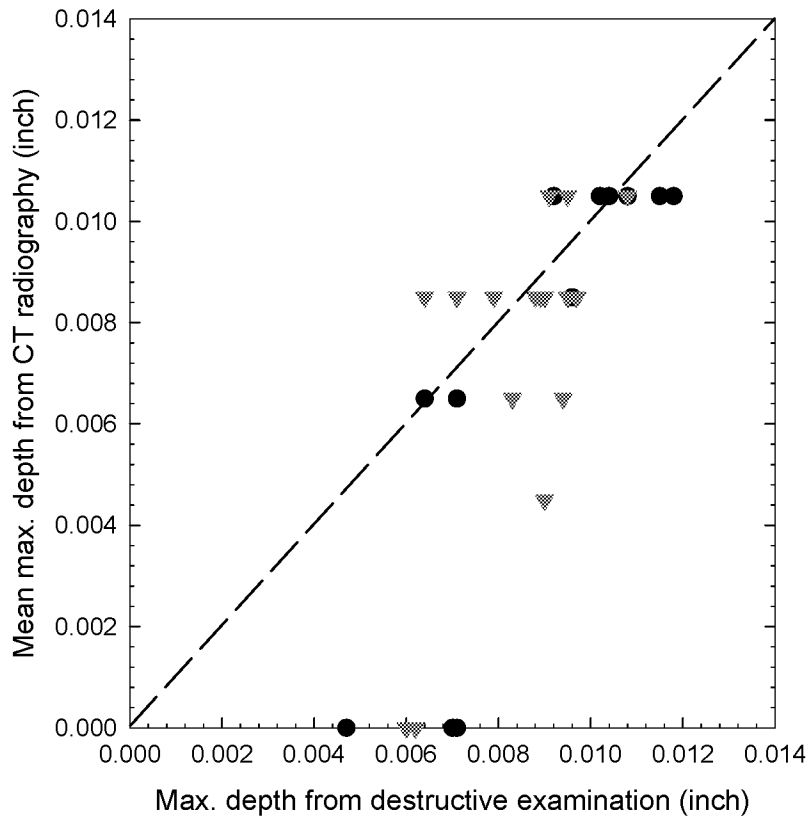
Two additional corroded (24 hour) specimens were examined to determine the accuracy of the CT radiography system in measuring IGA. The CT radiographic inspections were conducted at the same depths describe above; thus categorizing the IGA events at mean maximum corrosion depths of 0.0045, 0.0065, 0.0085, 0.0105 or 0.0125-inch. After CT radiography of the two corroded specimens was completed, a total of 32 metallographic cross-sections were microscopically examined. Each IGA corrosion event was characterized for depth, width and location and compared to the CT radiography results. Figure 6 is a plot of the mean maximum depth for 27 IGA events determined by CT radiography versus the maximum depth of the same events determined by the destructive examinations. Table I summarizes the statistical analysis of the data presented in Figure 6. A 95% confidence interval was determined for CT radiography results at the 0.0065, 0.0085, and 0.0105-inch mean maximum depths. If CT radiography indicates that an IGA event is 0.0105-inch deep, there is a 95% certainty that the event is between 0.0086 and 0.0122-inch in depth. Due to a lack of data, it was not possible to determine confidence intervals for CT results less than 0.0065-inch and greater than 0.0105-inch. Based on these results, the CT radiographic method enables nondestructive characterization of the IGA corrosion samples and provides good standards for development of an inspection technique.

Figure 6. Plot of mean maximum depth of IGA events as determined by CT radiography versus maximum depth of the same IGA events as determined by a destructive examination for two cold plate samples exposed to an electrolyte solution for 24 hours while coupled to a steel cathode.

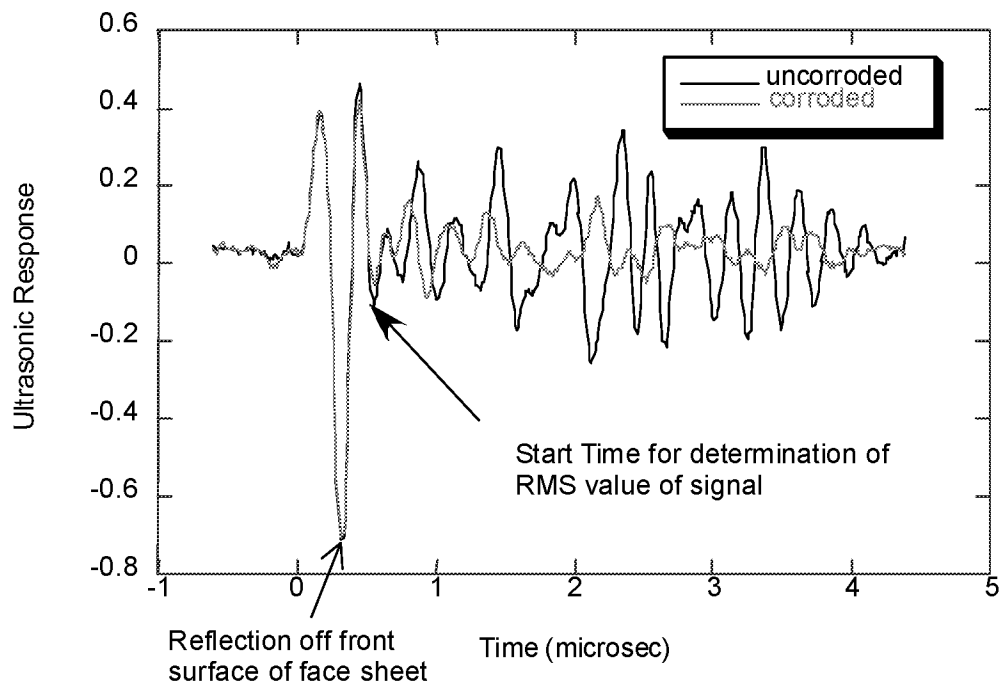
Figure 7. Ultrasonic response for immersion ultrasonic analysis for uncorroded and corroded cold plate samples.

Typical responses for corroded and uncorroded points on the specimen are shown in Figure 7. The initial response at both points is a strong reflection off the front surface. A frequency analysis indicates the measurement system bandwidth was approximately 3 to 6 MHz. This is too narrow to enable discrimination of the individual echoes from the back surface of the face sheet, which has a resonance

frequency of approximately 6 MHz. However, the RMS value of the ultrasonic response following the front surface echo is clearly less for the corroded point, than for the uncorroded point.

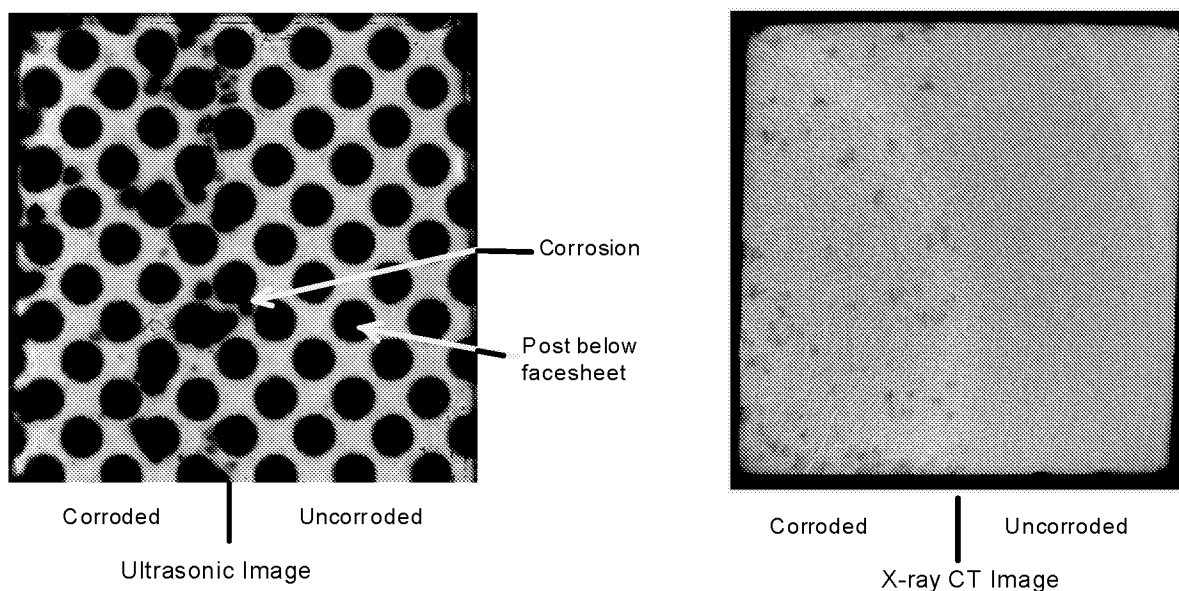
To image the corrosion, the RMS value of the ultrasonic response between 1 and 4 microseconds was calculated from the digitized waveforms. From these values it is possible to create an image such as shown in Figure 8. For comparison, a microfocus tomography image of the same specimen is also shown. Where there are posts below the face sheet, there are no echoes within the gated time, and the RMS value of the signal is small. This yields the round dark regions that are clearly visible in the image. Unlike the CT radiography technique, immersion ultrasonics does not provide a direct method for evaluating the penetration depth of the IGA events. An exact comparison of the ultrasonic and CT radiography was not possible due to difficulties registering the two images. However, qualitative agreement between the two images is reasonable. Future efforts will focus on a more quantitative comparison.

Figure 8. Immersion ultrasonic results for a corroded cold plate sample. The right half of the specimen was coated with wax to prevent corrosion, while the left half of the specimen was exposed to an electrolyte solution for 24 hours while coupled to a steel cathode.
